Eliminating Water Infiltration at Loading Docks

How to prevent product contamination, equipment damage and unsafe working conditions during material handling operations

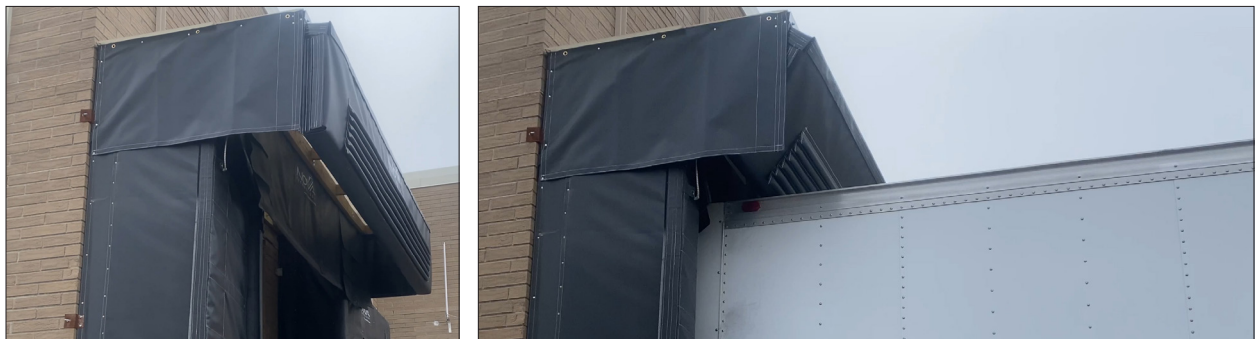
Multi-layer, foam-filled water defense system pivots with trailers as they approach the dock

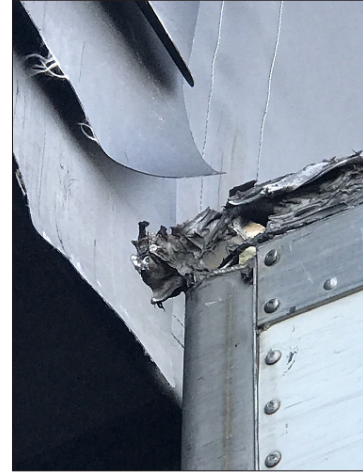
Trailer damage and irregularities create gaps where water can enter the dock

Another contributing factor to the presence of gaps and water infiltration can be due to the design, build and condition of the trailer. Some high-end trailers are well designed to shed water, where others are built to be cost-effective solutions in areas where rain is not an issue. Trailers with rear gutter systems allow significantly less water intrusion across loading dock door lanes because the rear portion of the trailer is designed to seal out, funnel and divert water to either side. However, when water-shedding features on trailers are defective or nonexistent, the result can act like a faucet and ultimately direct water across the loading door lane near the seal interface. There are several trailer features and defects that create gaps and contribute to water entering the loading dock area. These defects include dents from hail, rolling creases made when the trailer roof warps or bends and sharp edges created from punctures, damage or during the manufacturing process. Fastening strips that are not sealed properly or have a sharp angle can also channel standing water from the top surface to the rear corners and bypass traditional rain guards.
